Limited Visual Dam Safety Inspection Summary Report

MA-089

Reservoir 90

Maui, Hawaii

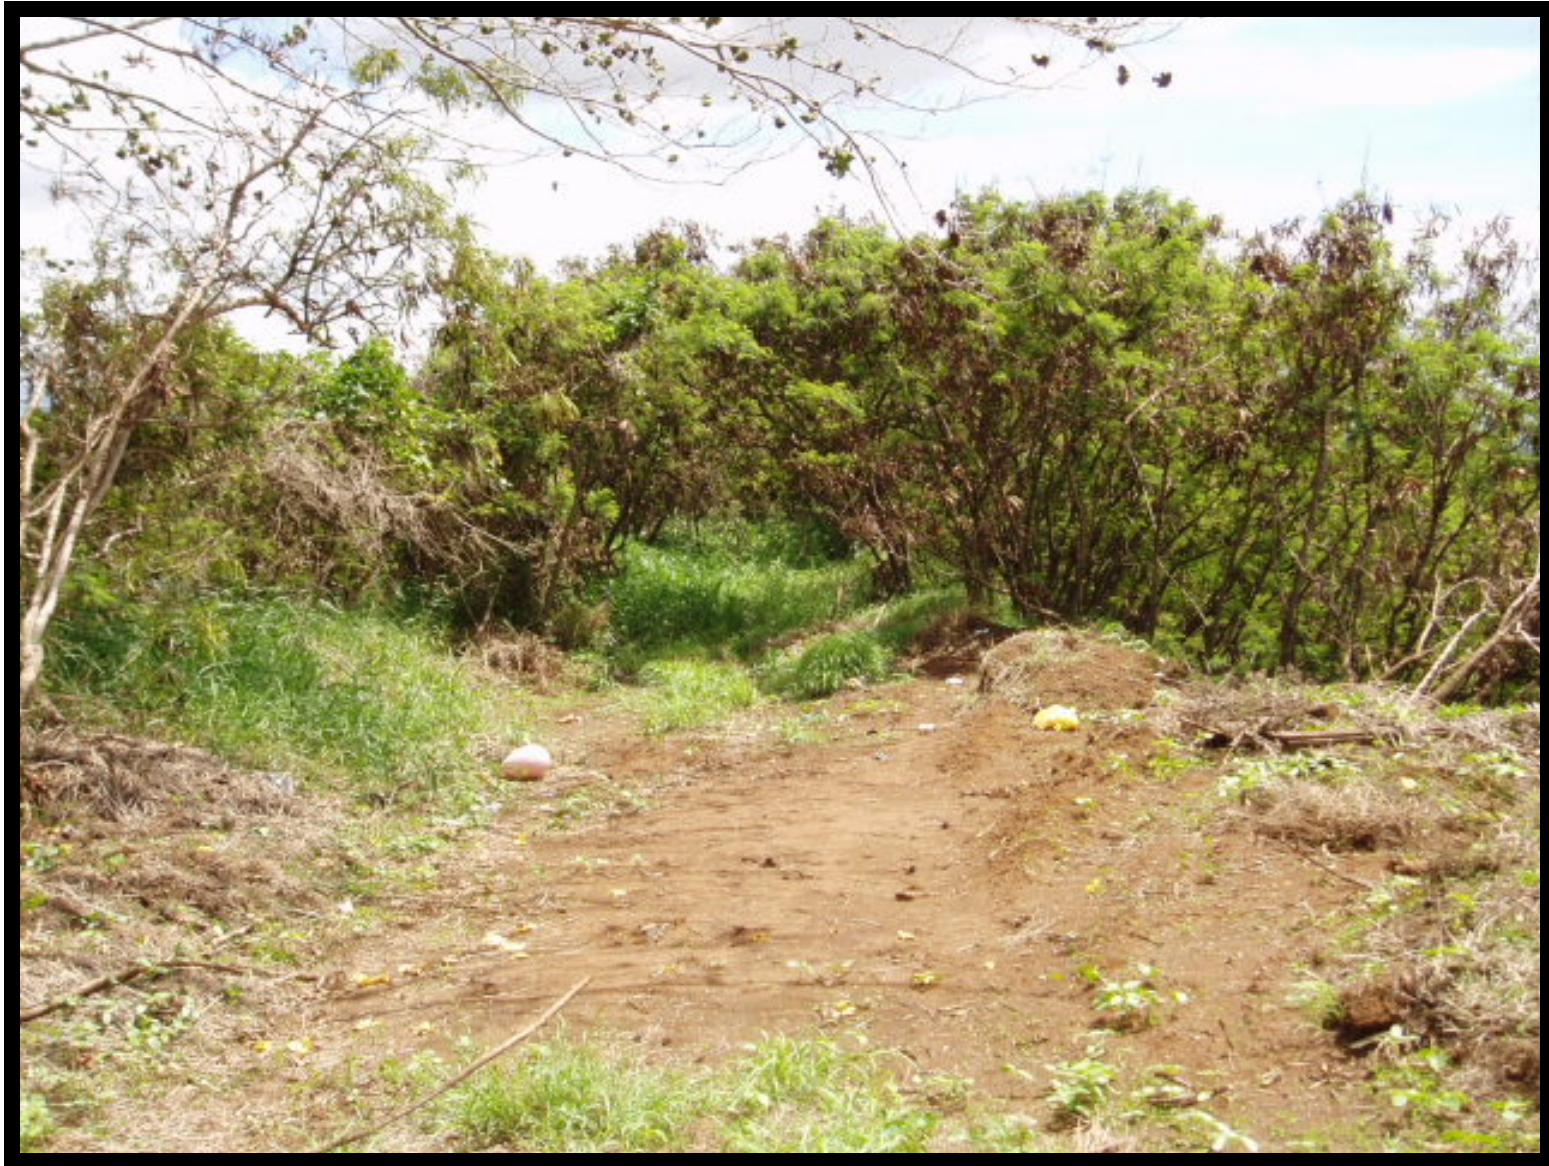
- a. The dam crest appeared to be in fair to poor condition and requires corrective action.
- b. Portions of the crest were not visible due to high grass and bush vegetation. Clear high vegetation and maintain low to enable easy visual inspection.
- c. Tree(s) were observed on the downstream slope. Trees have been identified as the probable cause of piping failures, and can possibly cause severe damage to the embankment if they are uprooted during high winds. Corrective action is required to remove the tree hazards from the dam. Acceptable remedies include removal of the tree and its root structure down to a 2" diameter and reconstructing the damaged embankment section. All repair work shall be accomplished as per the requirements of a licensed geotechnical or structural engineer. Routinely monitor the damaged area for signs of settlement and seepage.

089 Crest overgrown with vegetation.

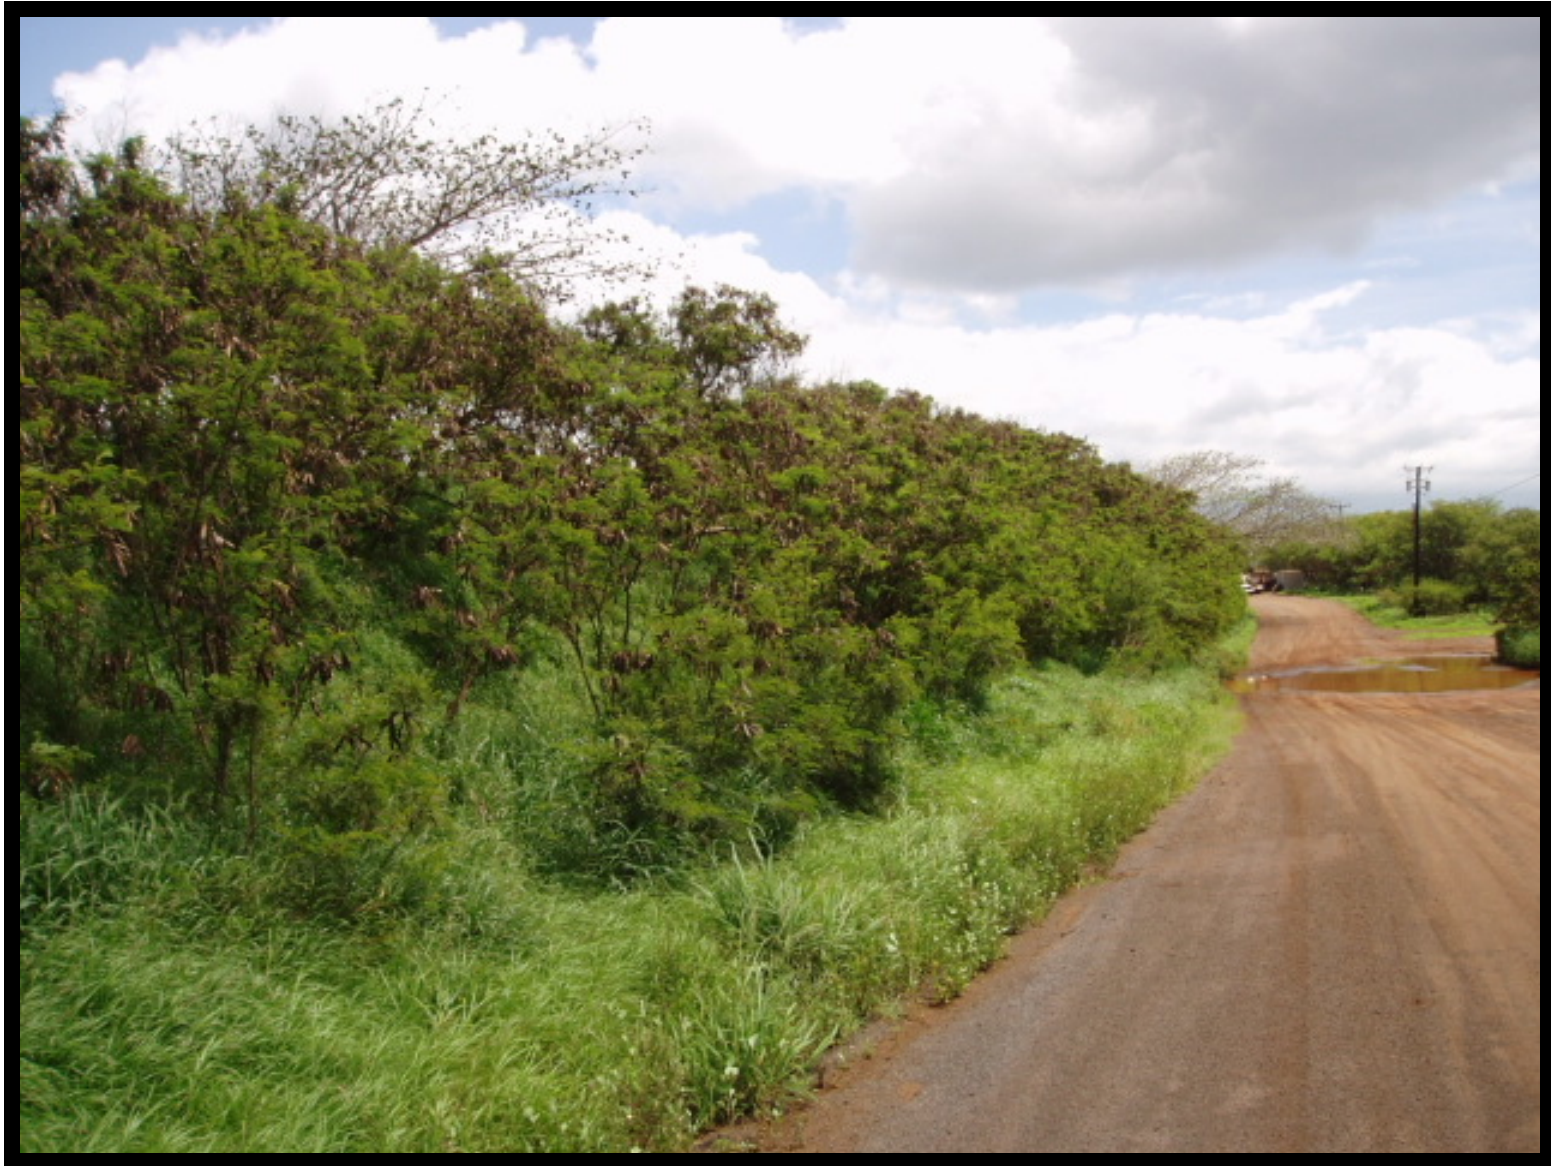
- a. The downstream slope appeared to be in fair to poor condition and requires corrective action.
- b. The downstream slope was not visible due to high grass and bush vegetation. Clear high vegetation and maintain low to enable easy visual inspection.

- c. Tree(s) were observed on the downstream slope. Trees have been identified as the probable cause of piping failures, and can possibly cause severe damage to the embankment if they are uprooted during high winds. Corrective action is required to remove the tree hazards from the dam. Acceptable remedies include removal of the tree and its root structure down to a 2" diameter and reconstructing the damaged embankment section. All repair work shall be accomplished as per the requirements of a licensed geotechnical or structural engineer. Routinely monitor the damaged area for signs of settlement and seepage.

089 Downstream slope of the dam. Note the dense vegetation on the slope.

- 1) Place erosion protection (i.e. riprap) on the upstream slope to the left of the spillway where benching is observed.
- 2) Remove underbrush and trees from the embankment. Grasses should be kept short.

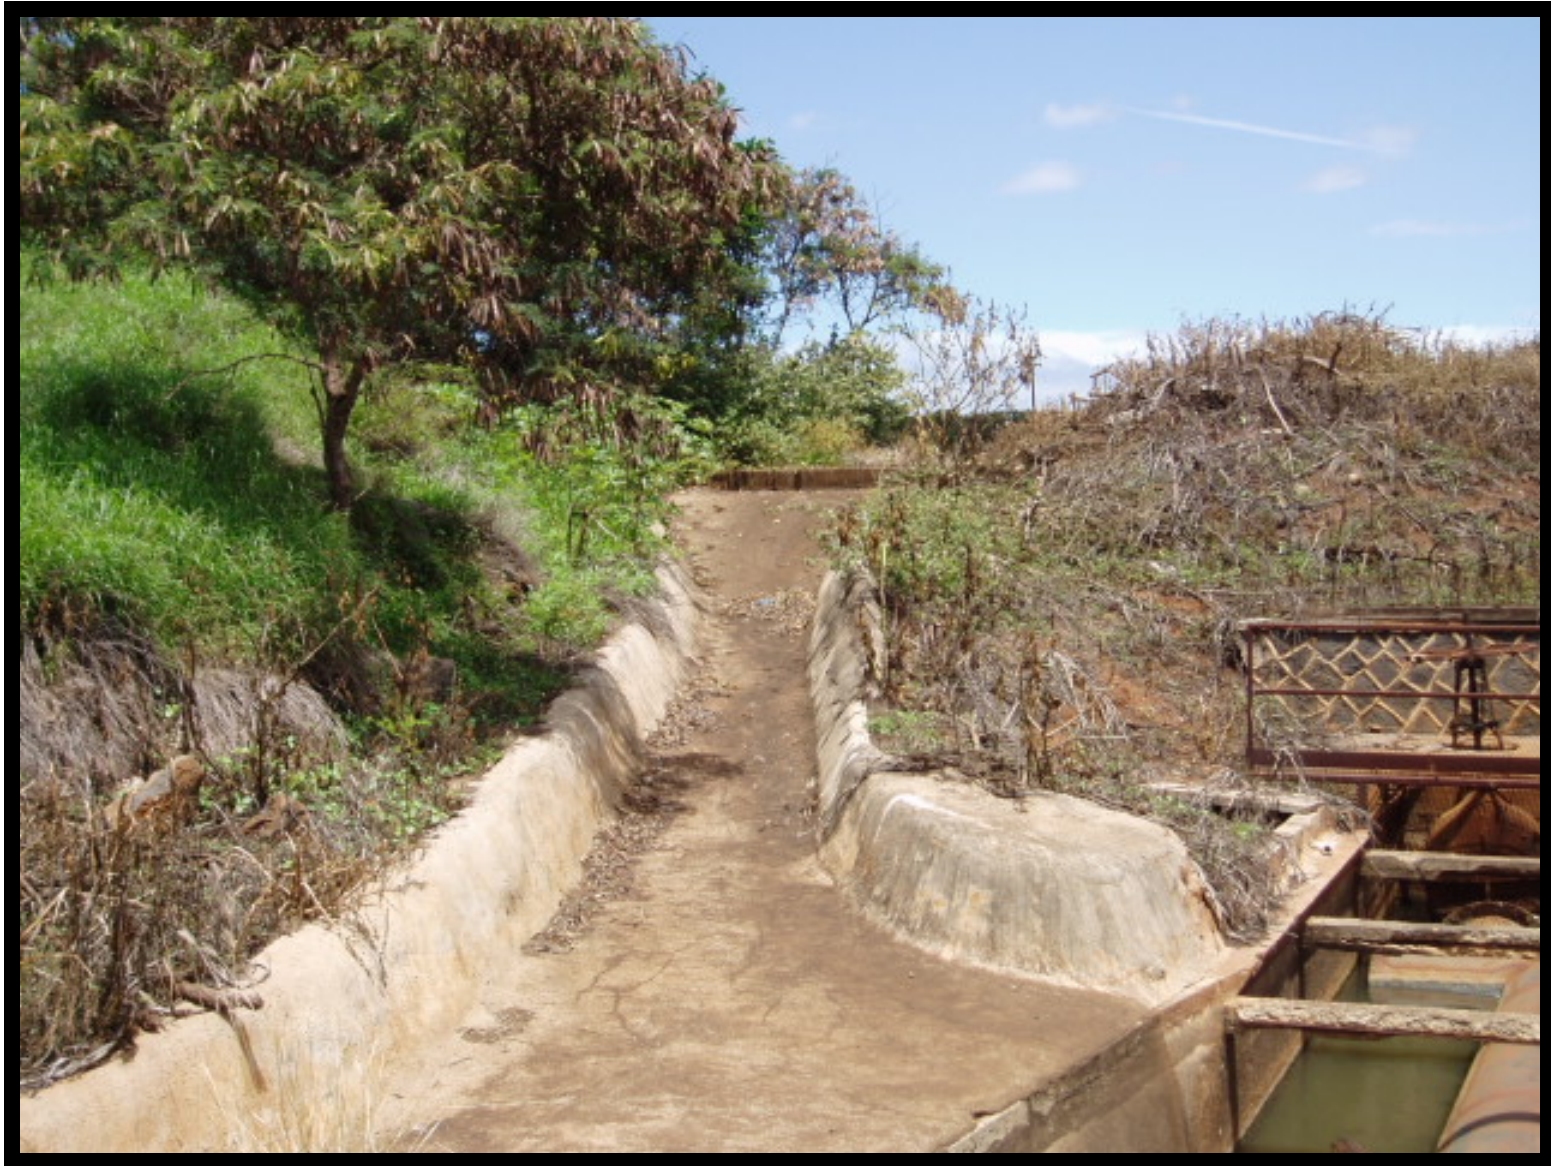
- a. The Spillway appeared to be in fair to poor condition and requires corrective action.
- b. Remove vegetation on right side of the spillway approach channel.

089 spillway

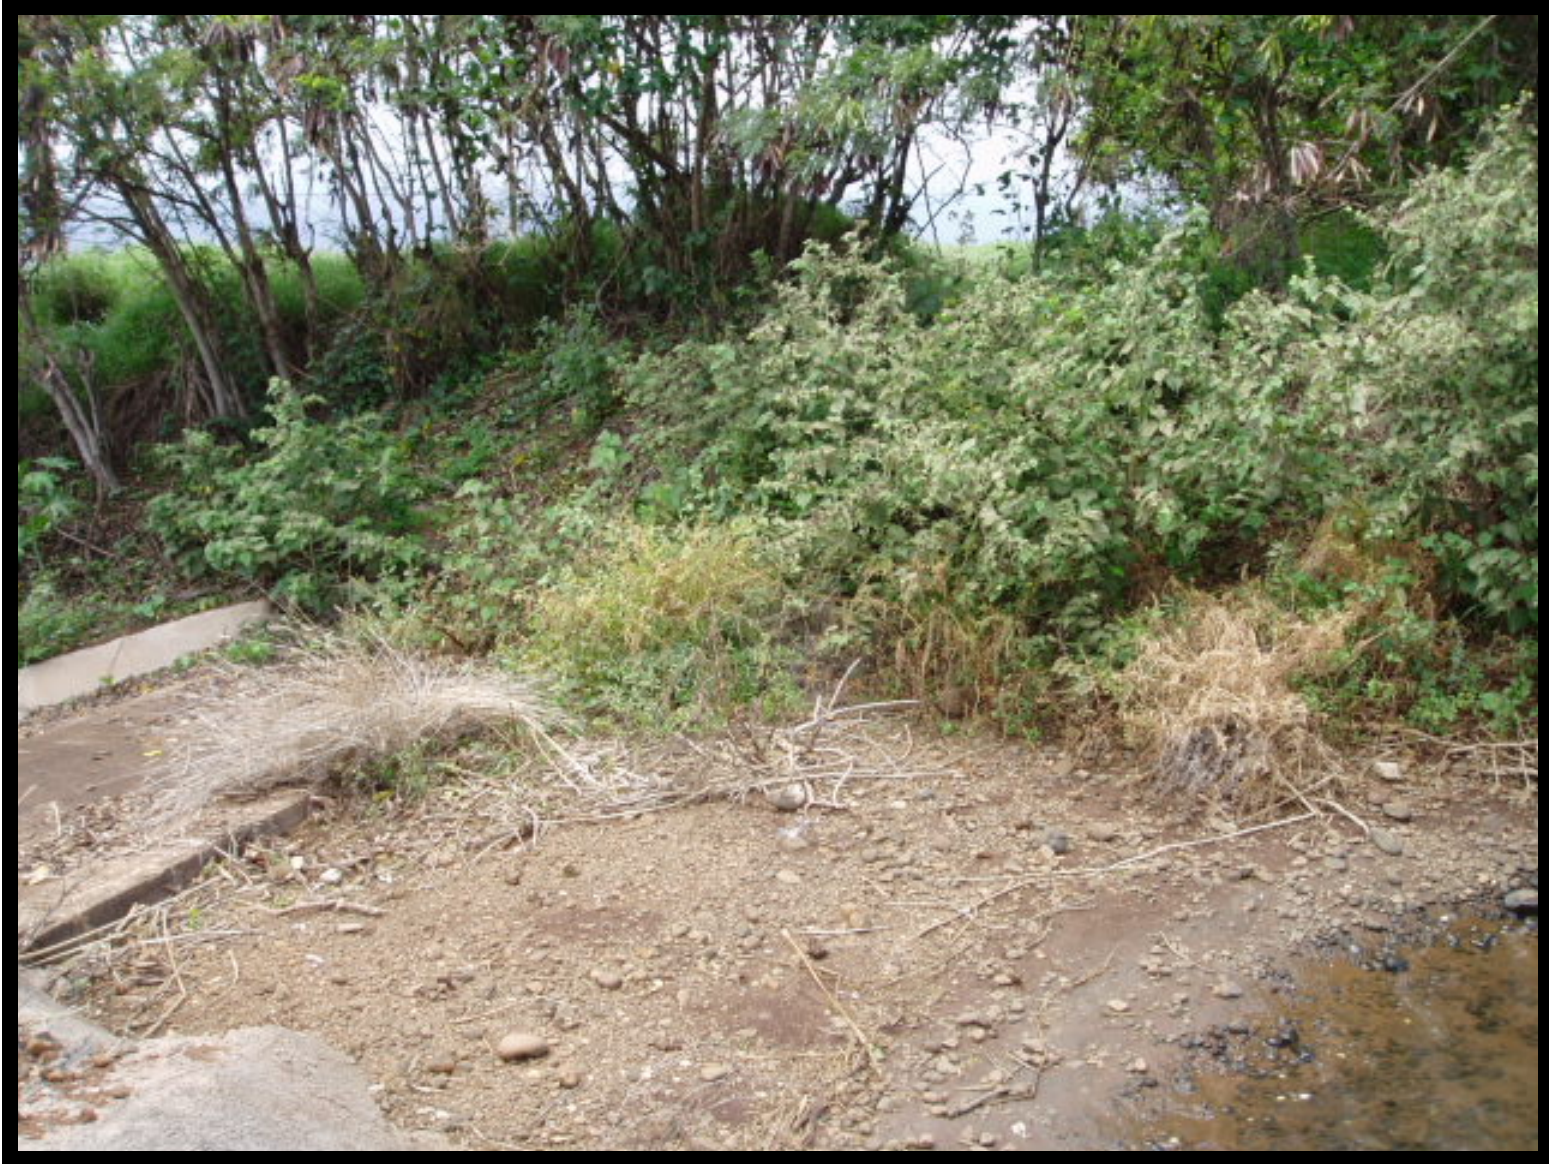
089 Vegetation at the spillway approach channel.

- ☐ d. Slope protection needs maintenance or repair. Description: _____
- ☐ e. The spillway approach was blocked. Clear approach.
- ☐ f. Severe scour erosion was observed which requires maintenance and/or repair.
Description: _____
- ☐ g. A headcut (vertical drop in channel due to erosion) was observed downstream of the spillway. Corrective action is required to prevent this problem from moving upstream.
- ☐ h. Trees are unacceptable in the spillway channel and approach. Take corrective action to address the woody vegetation problem and repair the damaged area.
- ☐ i. Unclear if spillway is adequately sized. Spillway should pass the probable maximum flood. Verify spillway capacity and take corrective action as required.
- ☒ j. Remove vegetation on right side of spillway approach channel.

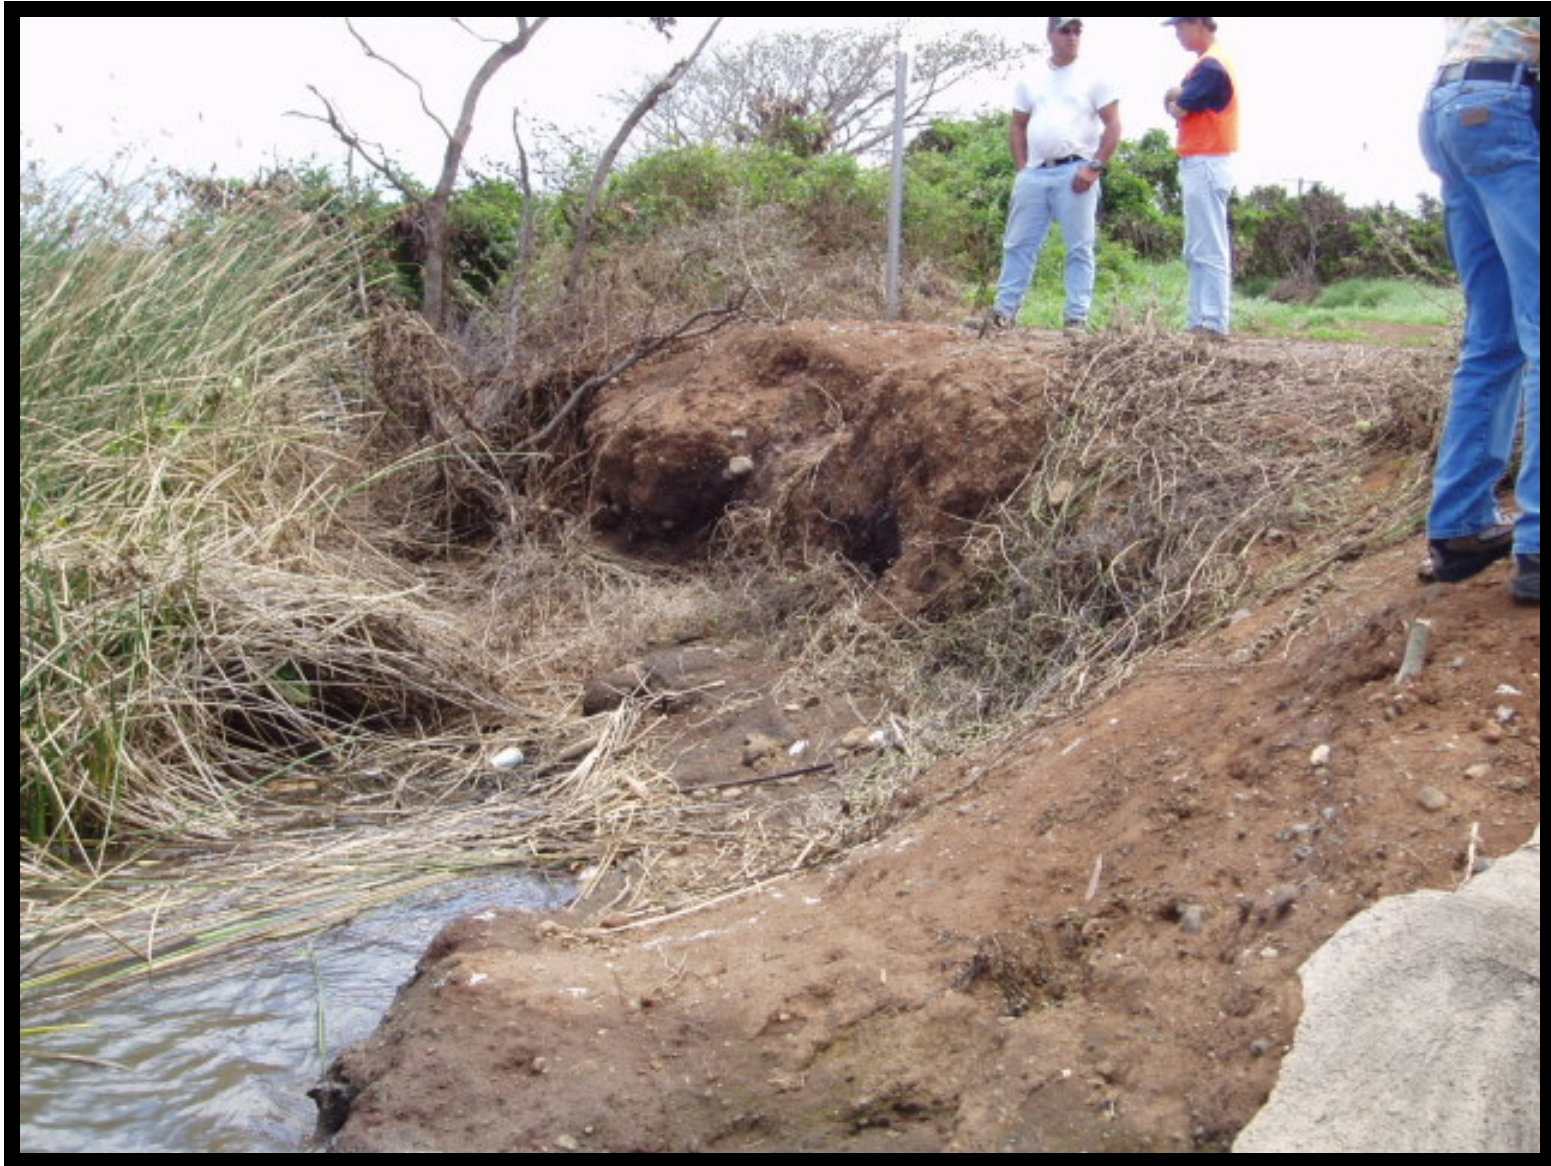
The upstream slope was 1 on 1 slope to 1 on 1.5 slope.
The upstream slope is protected by dumped rock. There is no riprap to the left of spillway and benching of the slope has occurred.
There is loose soil with little vegetation. There is a 3-foot high benching to the left of the spillway.
Cracks and sinkholes were not visible at the time of inspection.
The dense vegetation made inspection difficult with bushes, tall grass and lots of trees.

089 Benching on the upstream slope to the left of the spillway.

☐ Defect in Protection: Description: No riprap to the left of spillway. Benching of the slope is occurring

Place erosion protection (i.e., riprap) on the upstream slope to the left of the spillway where benching is observed.
